# YOUR ONESURVEY HOME REPORT

10 Adamton Terrace  
Prestwick  
KA9 2DW

# SINGLE SURVEY

# Single Survey

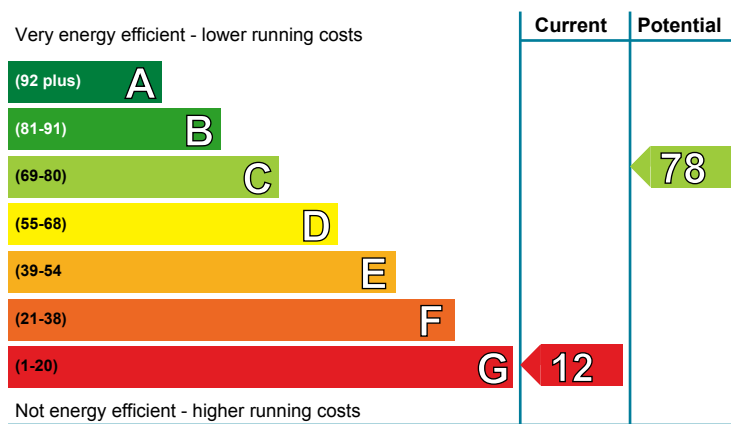
## Energy Efficiency Rating

This graph shows the current efficiency of your home, taking into account both energy efficiency and fuel costs. The higher this rating, the lower your fuel bills are likely to be.

Your current rating is **band G (12)**. The average rating for EPCs in Scotland is **band D (61)**.

The potential rating shows the effect of undertaking all of the improvement measures listed within your recommendations report.

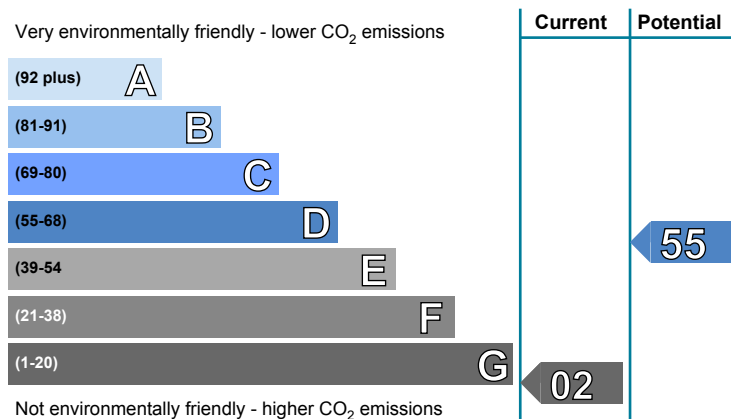
## Environmental Impact (CO<sub>2</sub>) Rating

This graph shows the effect of your home on the environment in terms of carbon dioxide (CO<sub>2</sub>) emissions. The higher the rating, the less impact it has on the environment.
