# YOUR ONESURVEY HOME REPORT

5 Adamton Terrace  
Prestwick  
KA9 2DW

# SINGLE SURVEY

A report on the condition of the property, with categories being rated from 1 to 3.

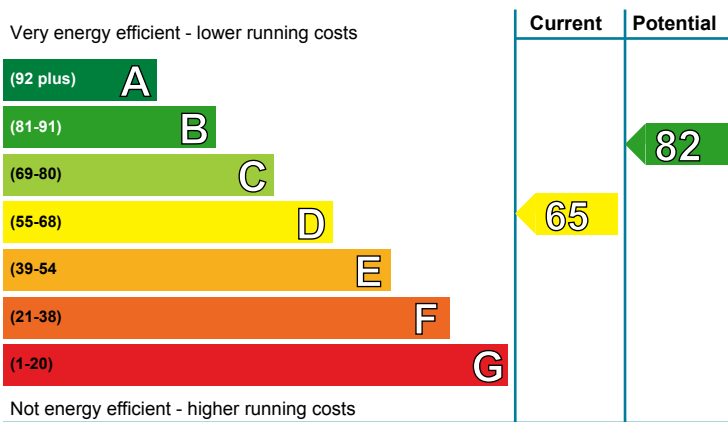
## Energy Efficiency Rating

This graph shows the current efficiency of your home, taking into account both energy efficiency and fuel costs. The higher this rating, the lower your fuel bills are likely to be.

Your current rating is **band D (65)**. The average rating for EPCs in Scotland is **band D (61)**.

The potential rating shows the effect of undertaking all of the improvement measures listed within your recommendations report.
